Asbestos & Lead-Based Paint Survey Report

Renovation, Public Park Building

Site: Spreckels Memorial Park, Spreckels, California

S Tech Project: 20131

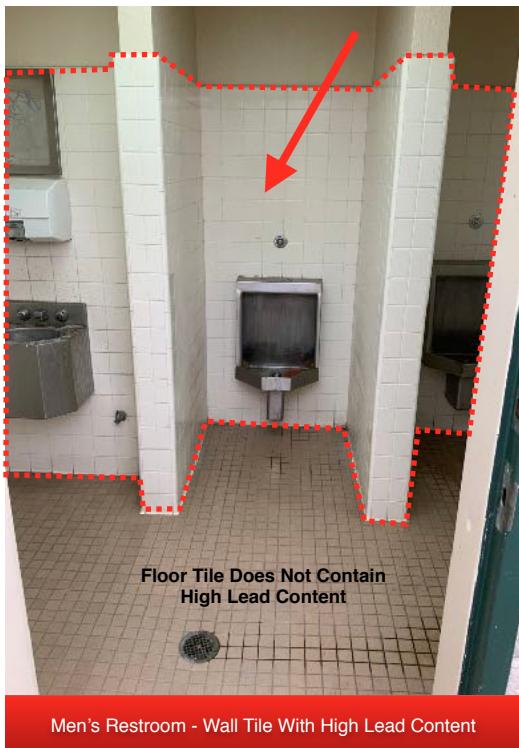
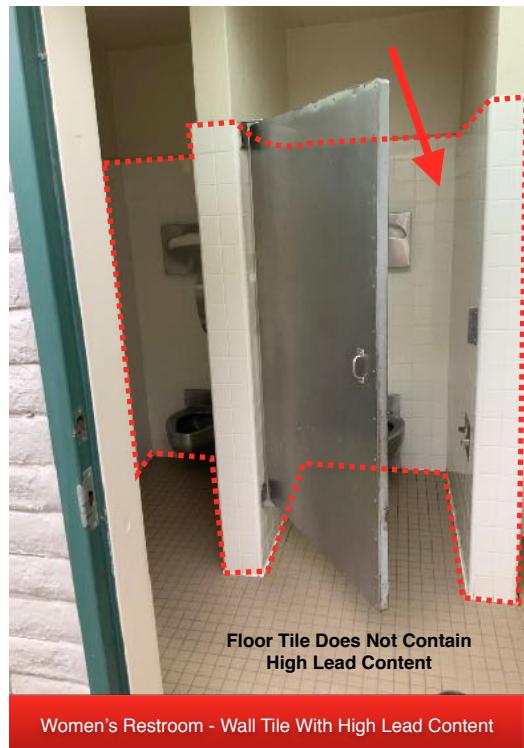
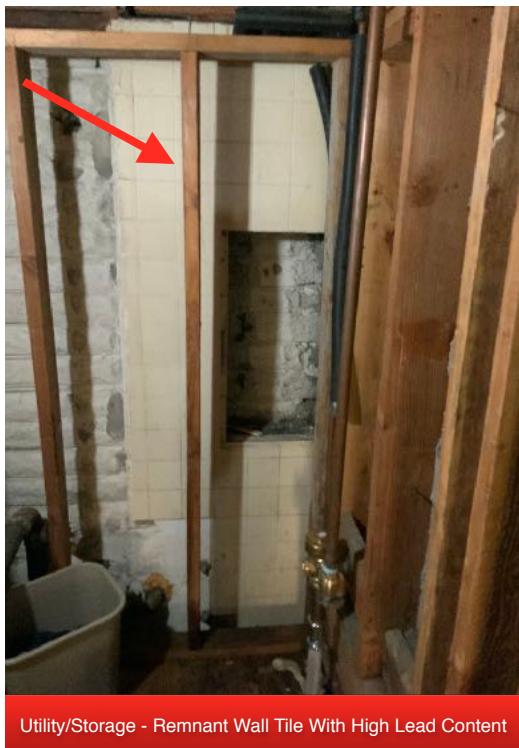
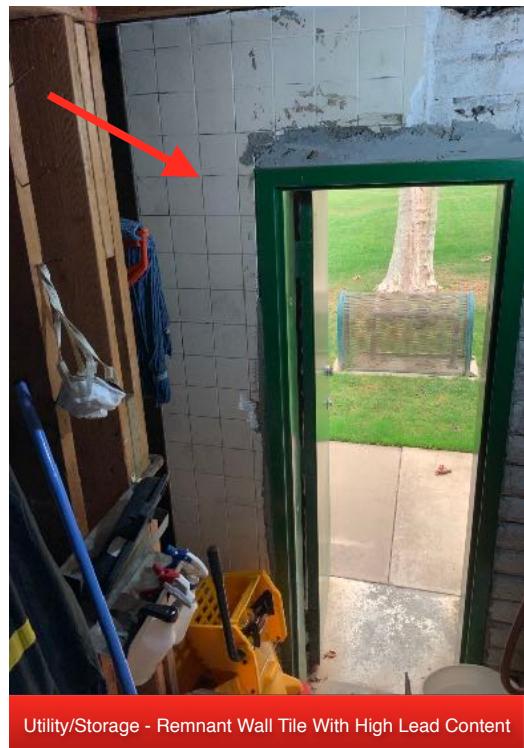
S e l e c t e d S i t e P h o t o s

- * **EPA defined Lead-Based Paint (>1.0 mg/cm² by XRF) was not identified in any of the coatings anticipated to be impacted by the scope of the renovations.**
- * **Elevated lead content is present in the ceramic tile finishes in the men's and women's restrooms and storage/utility closet. Uncontrolled demolition of ceramic finishes has the potential to release lead containing particulate once the glaze is shattered.**
- * **For contractor employee OSHA compliance, all paints and ceramic tile had a quantifiable lead content and are subject the requirements of the Cal-OSHA Lead in Construction Standard (Title 8 CCR Section 1532.1) when conducting trigger tasks which could result in occupational exposure to lead. Such high risk trigger tasks include abrasive blasting, flame torch usage, and mechanical grinding.**

Ceramic tile applications, where high lead content was identified, can release lead particulate during demolition activities, creating a lead risk hazard for building employees and contract staff. Lead-safe work practices should be implemented during ceramic tile removal to ensure lead particulate is appropriately contained. HEPA vacuums should be used when conducting cleaning after demolition work. All wastes must be appropriately disposed of.
