Limited Asbestos & Lead-Based Paint Survey Report *Renovation, Commercial Property*

Site: 90 Fifth Street, Spreckels, California

S Tech Project: 18040

March 19, 2018

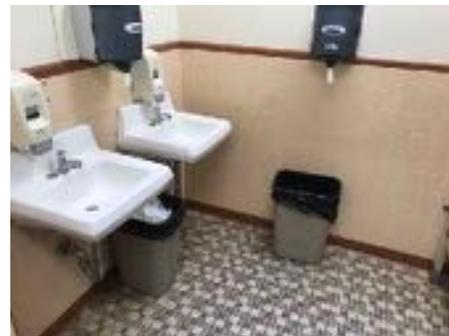
Interior walls and ceilings within the assessment area are plaster with a button board backing. There is also ceramic wall tile adhered to the plaster walls in both restrooms.

Flooring that will be impacted by the renovation work includes ceramic floor tile.
